# **INDOOR AIR QUALITY ASSESSMENT**

**Dolbeare Elementary School  
340 Lowell Street  
Wakefield, Massachusetts**

Prepared by:  
Massachusetts Department of Public Health  
Bureau of Environmental Health Assessment  
May, 2000

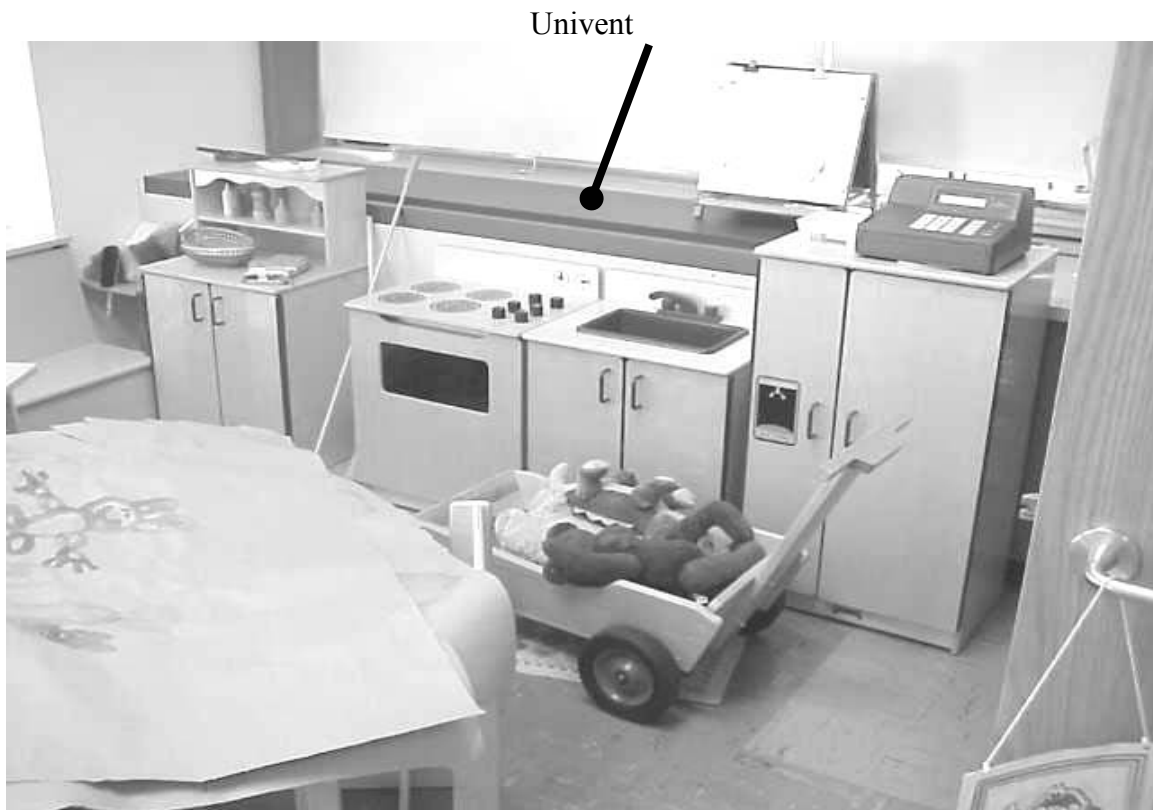
**Picture 1**

consistent basis. Obstructions to airflow, such as items stored on univent air diffusers as well as computer carts and furniture in front of univent return vents were also noted in classrooms (see Picture 1). In order for univents to provide fresh air as designed, univent air diffusers and return vents must remain free of obstructions. Importantly, these units must remain activated while classrooms are occupied. Rooftop air-handling units (AHUs) provide ventilation for the common areas (e.g., office areas, gymnasium, cafeteria, etc.). These units were operating during the assessment.

**Classroom Univent: Note Return Vent (front-lower portion of unit) is Blocked With Items Obstructing Airflow**

3. Have exhaust ventilation operate during occupancy. Inspect exhaust motors and belts for proper function, repair and replace as necessary.
4. Remove all blockages from univents and exhaust vents. Examine flue systems for proper function, repair if necessary.

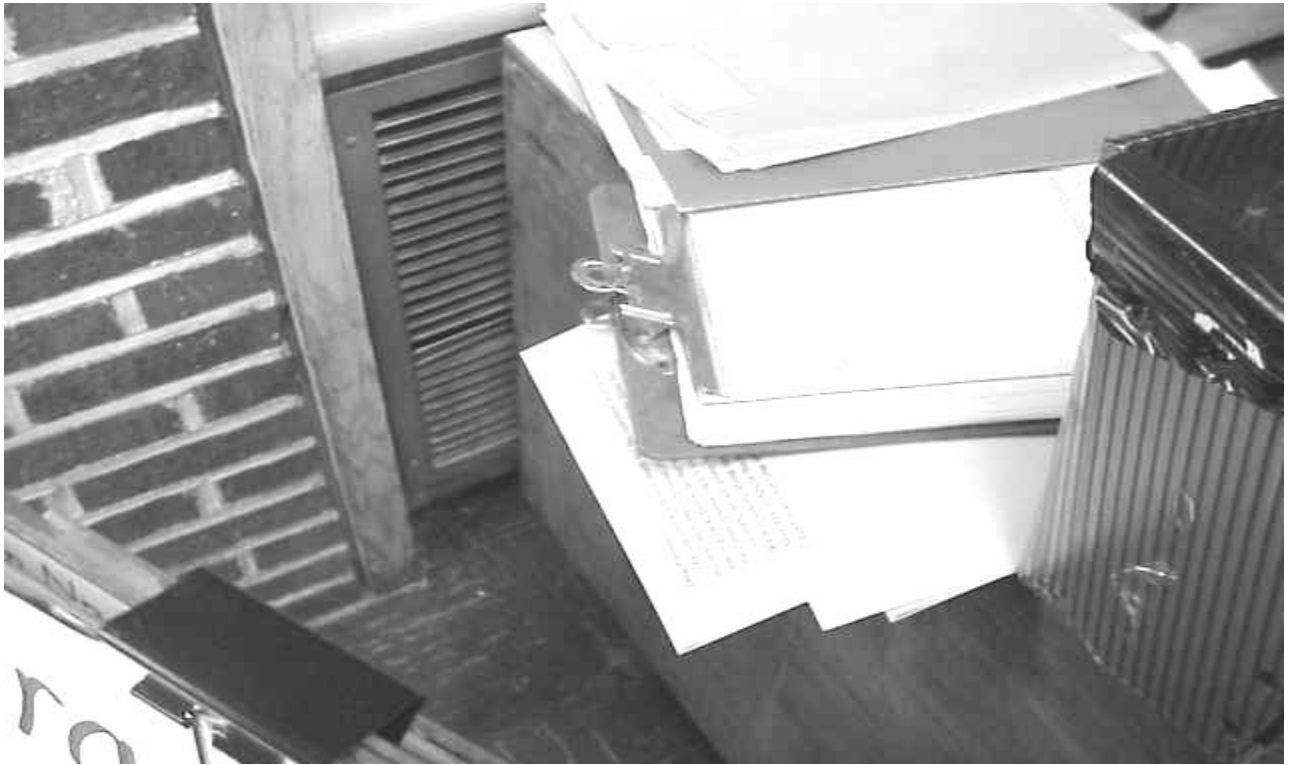
**Picture 3**

**Classroom Exhaust Vent Obstructed by Bookshelf**

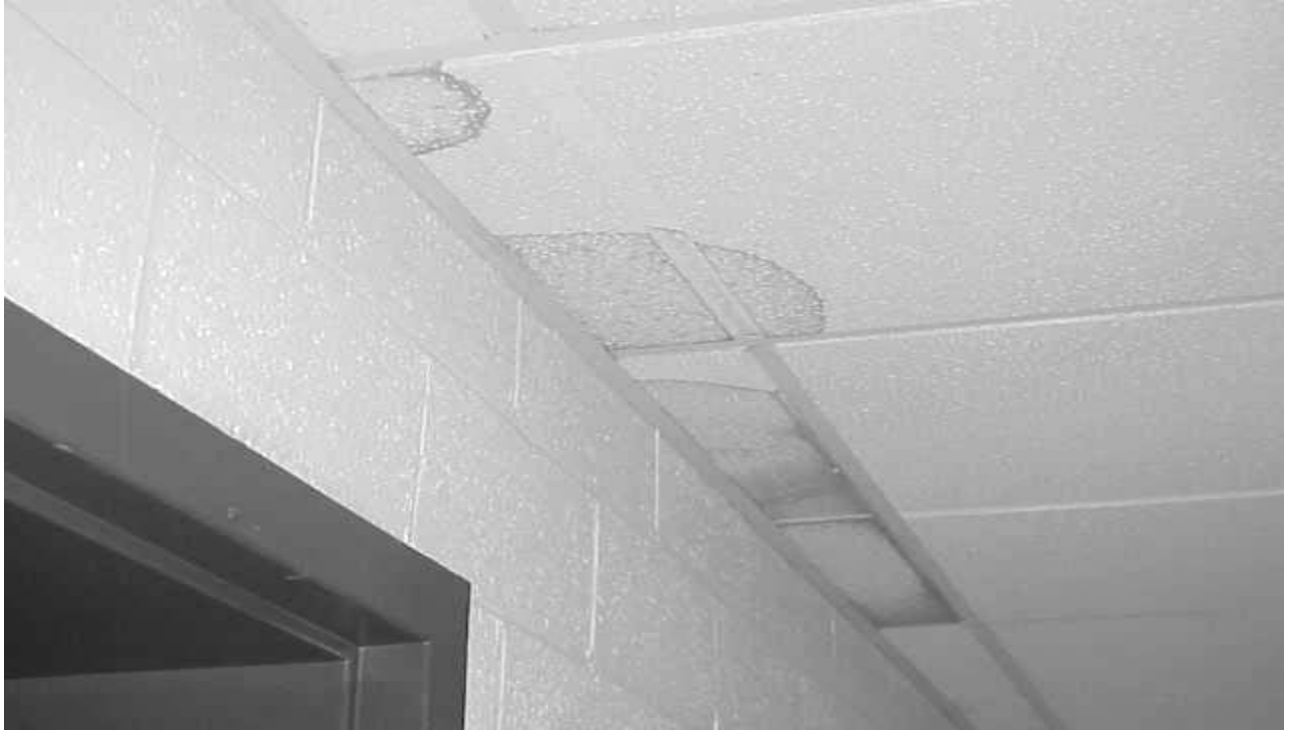
**Picture 4**

Several areas had water-stained ceiling tiles (see Picture 4), which are evidence of historic roof or plumbing leaks. Water-damaged ceiling tiles can provide a source of mold and mildew and should be replaced after a water leak is discovered, and repaired.

**Water Stained Ceiling Tiles**

8. Repair any existing water leaks and replace any remaining water-stained ceiling tiles. Examine the areas above these tiles for mold growth. Disinfect areas of water leaks with an appropriate antimicrobial as needed.

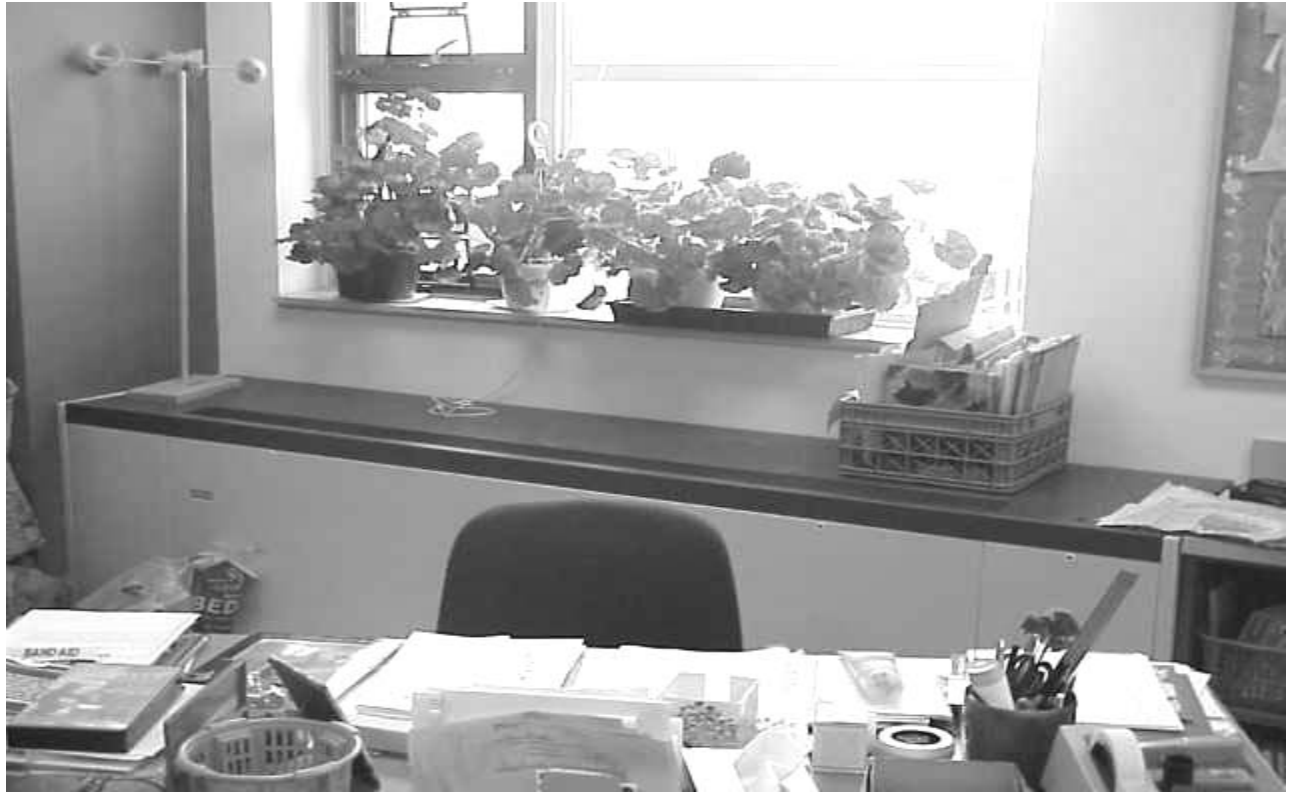
**Picture 5**

Several classrooms had a number of plants. Moistened plant soil and drip pans can serve as a source of mold growth. Classroom 202 had flowering plants on top of univents (see Picture 5). Plants should be equipped with drip pans and located away from univents to prevent the aerosolization of dirt, pollen or mold.

**Flowering Plants Noted Over Univent Air Diffuser in Classroom**

9. Move plants away from univents in classrooms. Ensure drip pans are placed underneath plants in classrooms. Examine drip pans periodically for mold growth and disinfect with an appropriate antimicrobial where necessary.

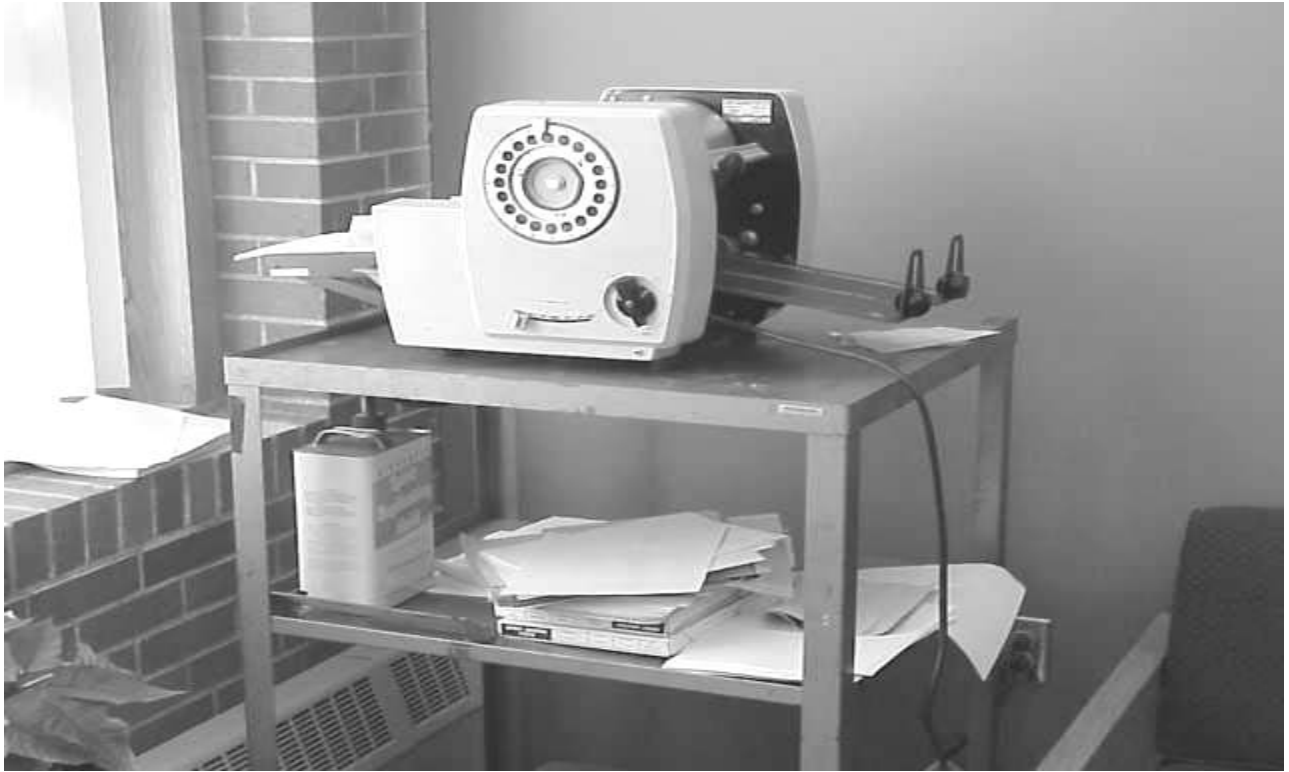
**Picture 6**

Several other conditions were noted during the assessment, which can affect indoor air quality. The teacher's workroom contained two lamination machines and two photocopiers. Also noted were a mimeograph machine and a container of mimeograph duplicating fluid (see Picture 6). Lamination machines can produce heat and irritating odors during use. Mimeograph duplicating fluid contains methanol (methyl alcohol), which is a volatile organic compound that readily evaporates at room temperature. The off gassing of this material can also be irritating to the eyes, nose and throat. Methanol is also a highly flammable material, which can be ignited by either flame or electrical source. Excess heat, volatile organic compounds (VOCs) and ozone can be produced by photocopiers, particularly if the equipment is older and in frequent use. Ozone is a respiratory irritant (Schmidt Etkin, D., 1992). Occupants should ensure exhaust ventilation is activated while equipment is in use to help reduce excess heat and odors in this room.

**Mimeograph Machine and Duplicating Fluid Noted in Teacher's Workroom**

11. Ensure exhaust ventilation is activated in teacher's room to help reduce lamination machine and photocopier odors. Consider reducing or discontinuing use of mimeograph machines.

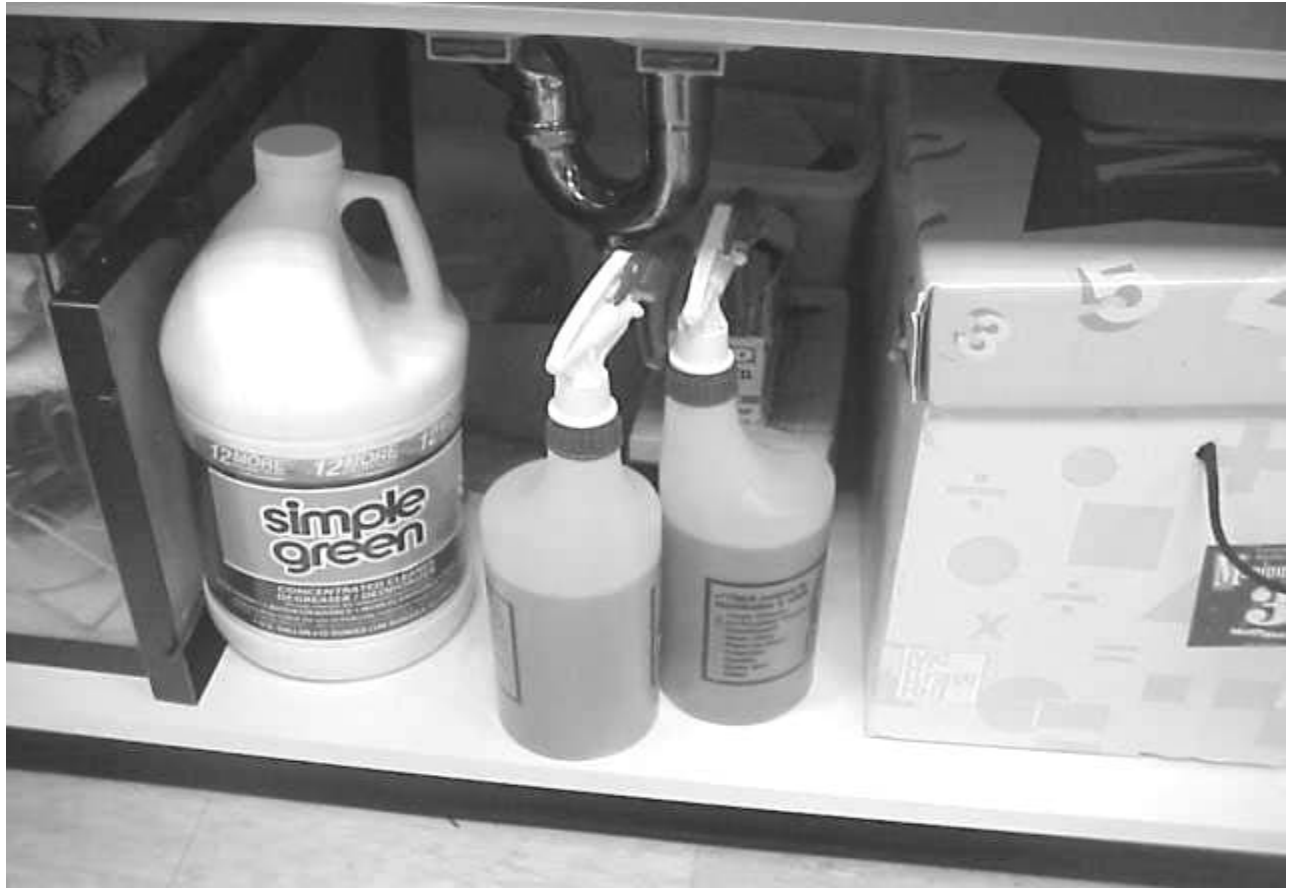
**Picture 7**

A number of classrooms contained dry erase boards and dry erase board markers. Materials such as dry erase markers and dry erase board cleaners may contain volatile organic compounds (VOCs), such as methyl isobutyl ketone, n-butyl acetate and butyl-cellusolve (Sanford, 1999). Cleaning products were stored under sinks as well as on tables and countertops in a number of classrooms (see Picture 7). These materials should be stored properly and kept out of reach of students. In addition, a number of classrooms contained unlabeled spray bottles. Products should be kept in their original containers, or should be clearly labeled as to their contents, for identification purposes in the event of an emergency. Cleaning products, dry erase board markers and cleaners can be irritating to the eyes, nose and throat.

**Cleaning Products Noted under Sink in Classroom**

12. Store chemicals and cleaning products properly and out of the reach of students. Be sure all materials are labeled clearly.
